FIRE PERFORMANCE EVALUATION OF *EL 80 WITH CERAMIC TILES*, IN ACCORDANCE WITH THE 2006 EDITION OF NATIONAL FIRE PROTECTION ASSOCIATION 286, STANDARD METHODS OF FIRE TESTS FOR EVALUATING CONTRIBUTION OF WALL AND CEILING INTERIOR FINISH TO ROOM FIRE GROWTH

FINAL REPORT
Consisting of 13 Pages

SwRI Project No. 01.13544.01.216a[1]
Test Date: April 23, 2008
Report Date: May 20, 2008

Client: LUX ELEMENTS GmbH & Co. KG
Project No.: 01.13544.01.216a[1]
Material ID: *EL 80 with ceramic tiles*
Trade Name: *LUX ELEMENTS - Hardfoam support element*

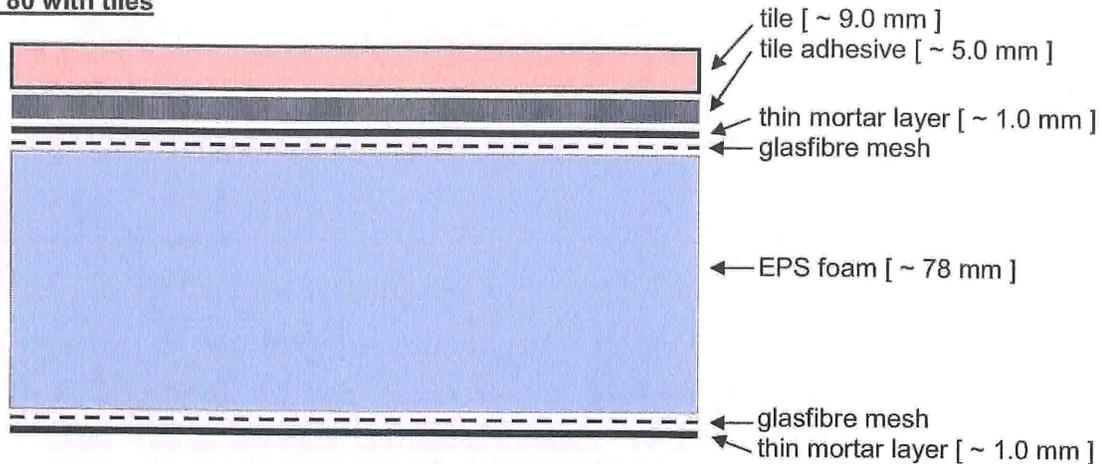
EL 80 with tiles

Figure 1. Material Layers in EL 80 Panel with Ceramic Tiles.

Material Description:* Expanded Polystyrene (EPS) Foam with Coating of Mortar and Glass Fiber Mesh, Covered with Ceramic Tiles.

Construction Details: SwRI constructed a 2 × 4-in. wood stud room with ½-in. thick gypsum wallboard on the walls and ceiling. Representatives of LUX ELEMENTS GmbH & Co. KG fastened *EL 80* panels to the ceiling of the test room using 4.75-in. screws and 2.75-in. washers, spaced every 21 in. around the perimeter. *EL 80* panels were also fastened to the back and side walls of the test room using 4.75-in. screws and 1.375-in. washers, placed 6 in. in from each corner, 6 in. in from mid-point of the side edges, and 30 in. from the top and bottom at the center of each panel. The joints were taped and floated with mortar. The ceramic tiles were then installed on the walls only, using approximately 5 mm of tile adhesive. See Figure 1 below, for a Client supplied diagram of *EL 80* panels with tiles.

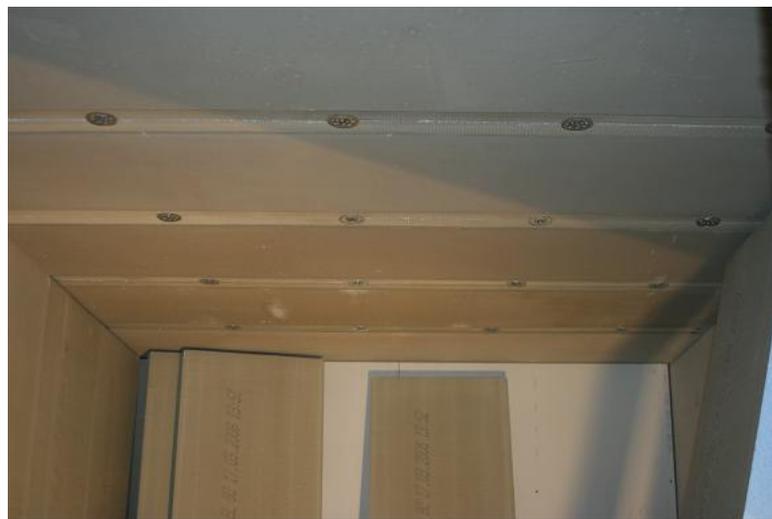
Figure 2. Ceiling Panels Installed, and Wall Panels Partially Installed.

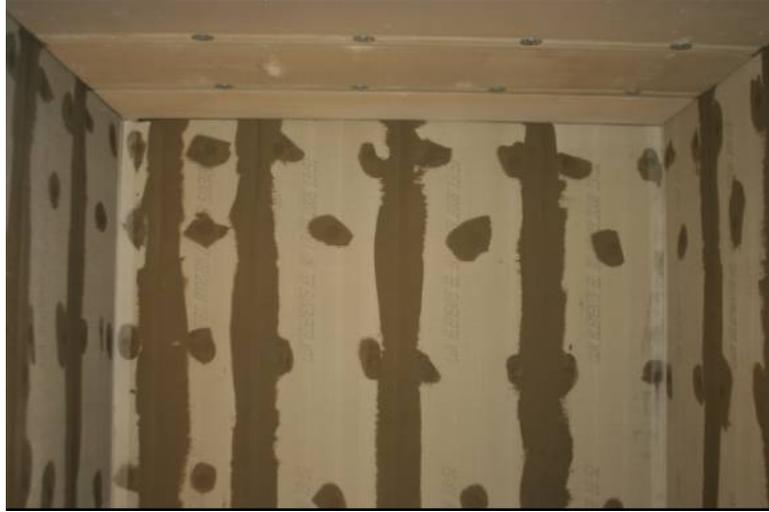
Figure 3. Walls Taped and Floated.

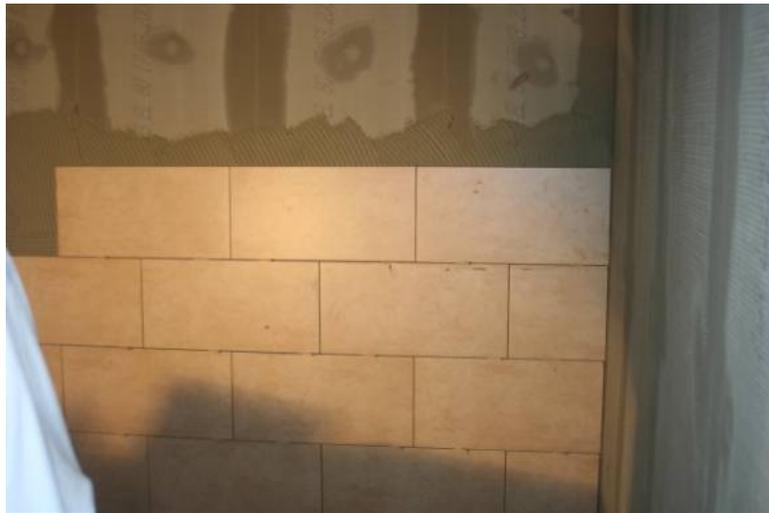
Figure 4. Tile Installation.

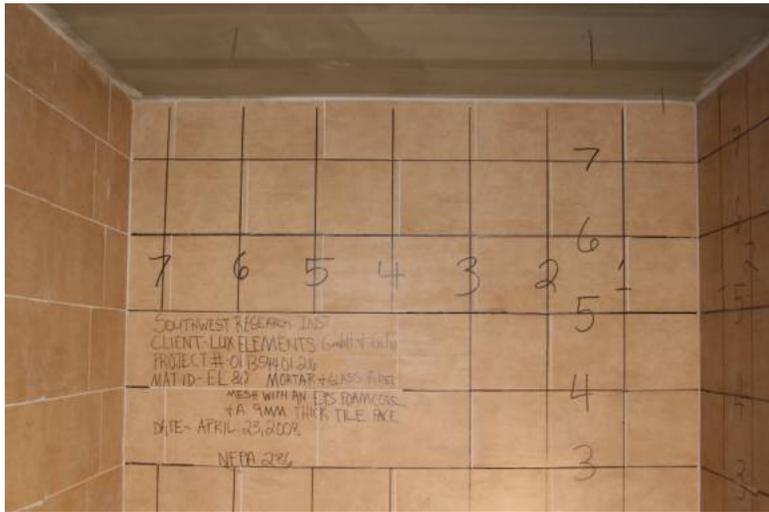
Figure 5. Pre-Test View of Completed Room.

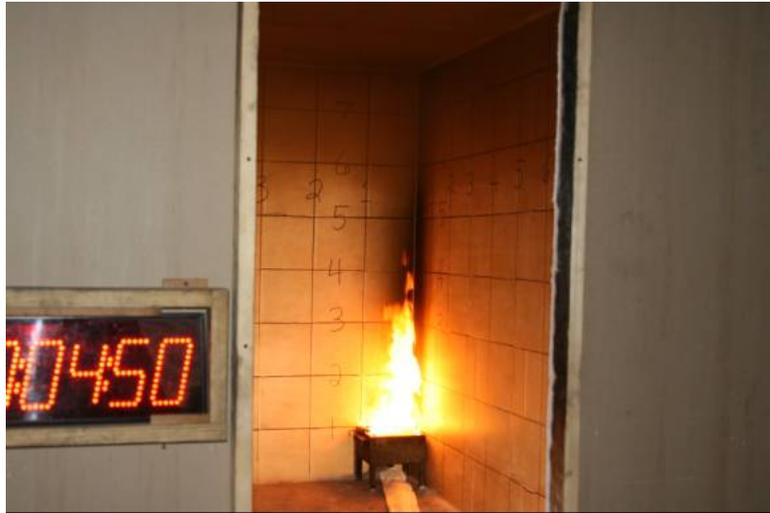
Figure 6. 4 min 50 s into Test; Burner at 40 kW.

03:00	Discoloration with scorching along both walls starting at the top of the burner up to 2½ ft and approximately 6 in. in width.
04:30	Very light grey layer of smoke in the room interior down to 5½ ft above the floor. Flames from burner are 3 to 3½ ft in height from floor.

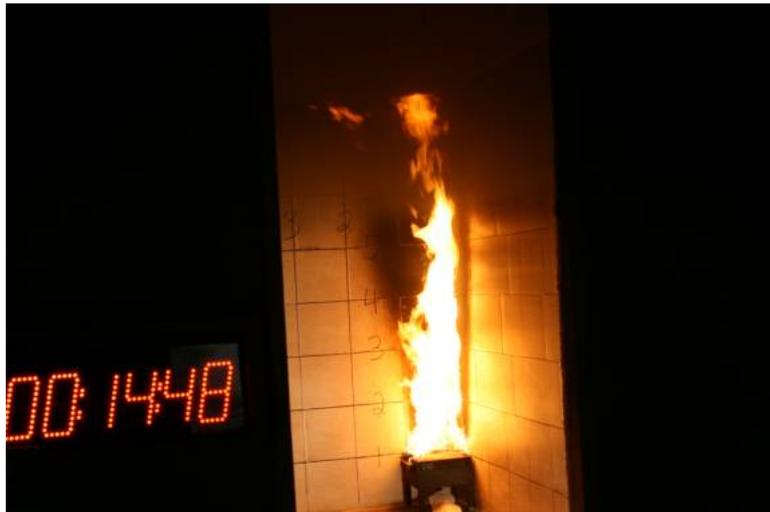
Figure 7. 14 min 48 s into Test; Burner at 160 kW.

14:30	No surface flaming on wall panels, intermittent flaming on ceiling panel at direct flame impingement from burner.
15:00	End of Test, burner extinguished. No afterflaming on walls or ceiling.

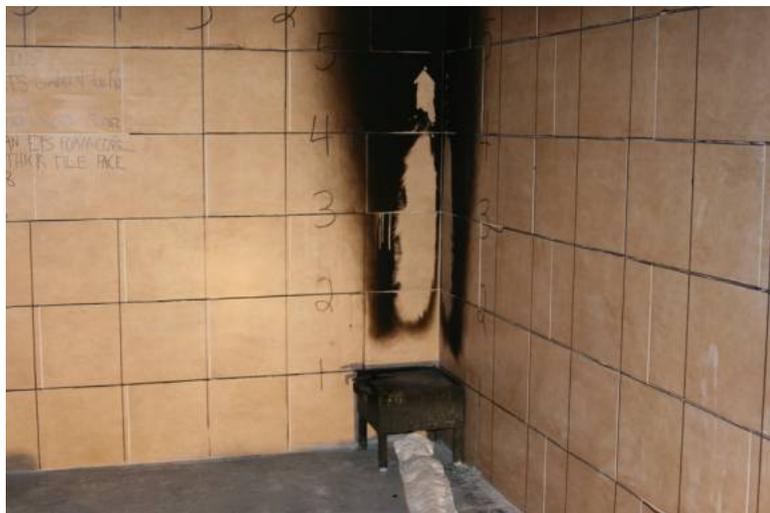
Figure 8. Post-Test View of Burn Corner.

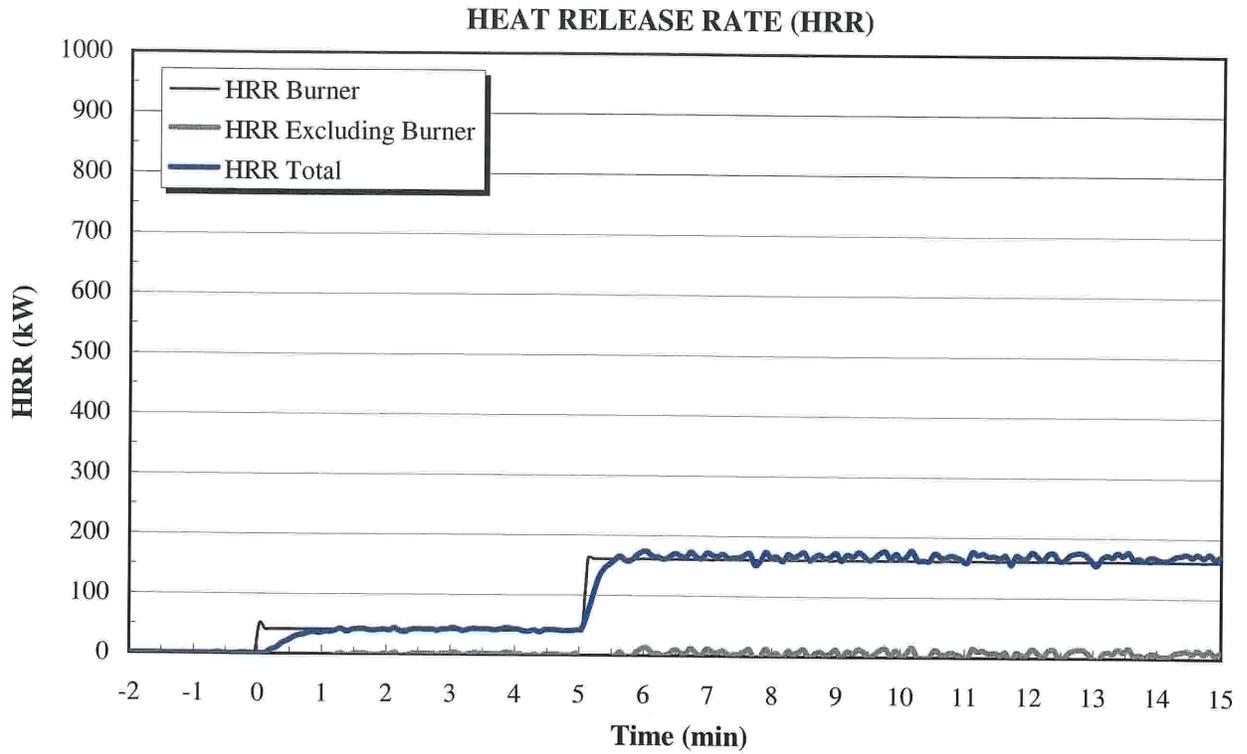
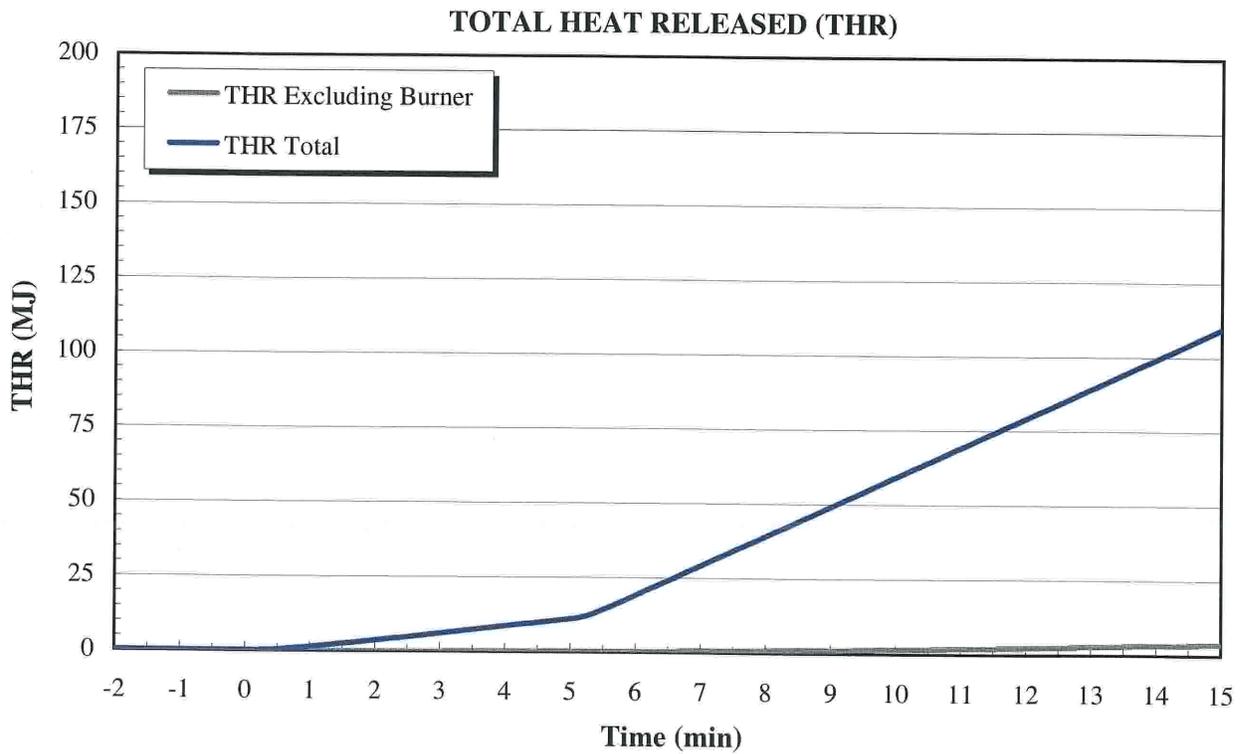
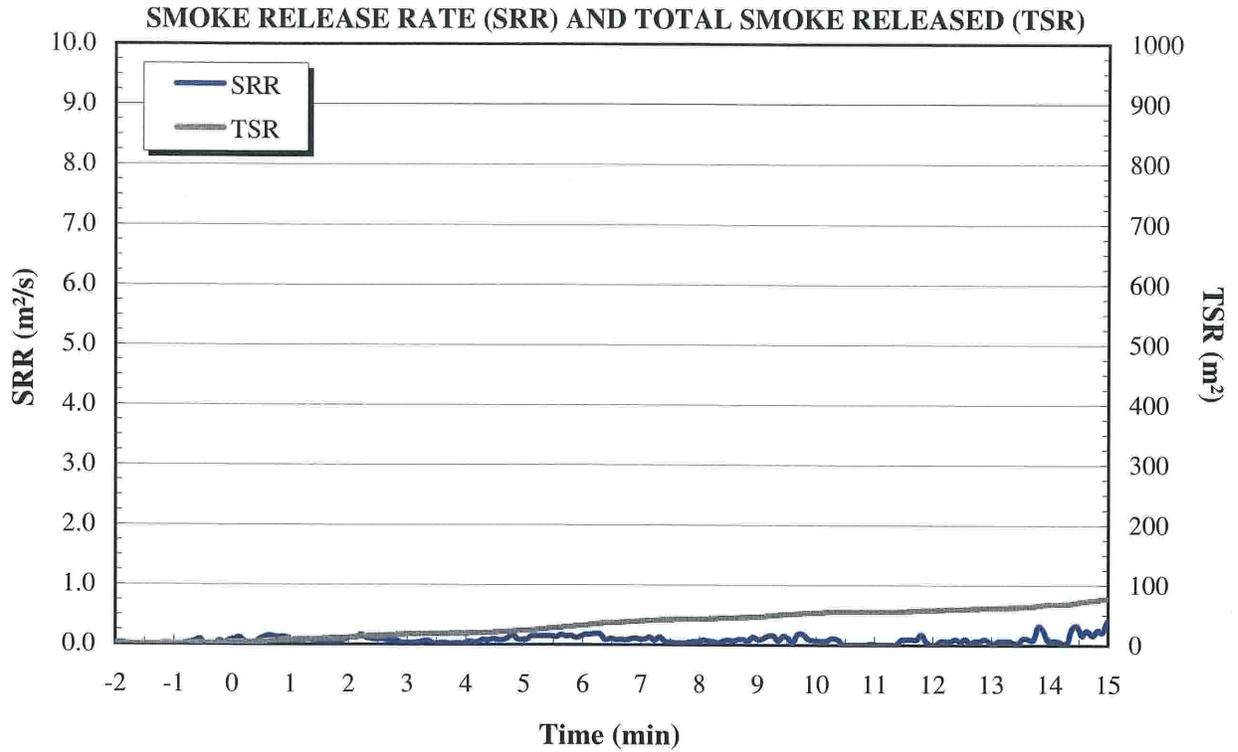
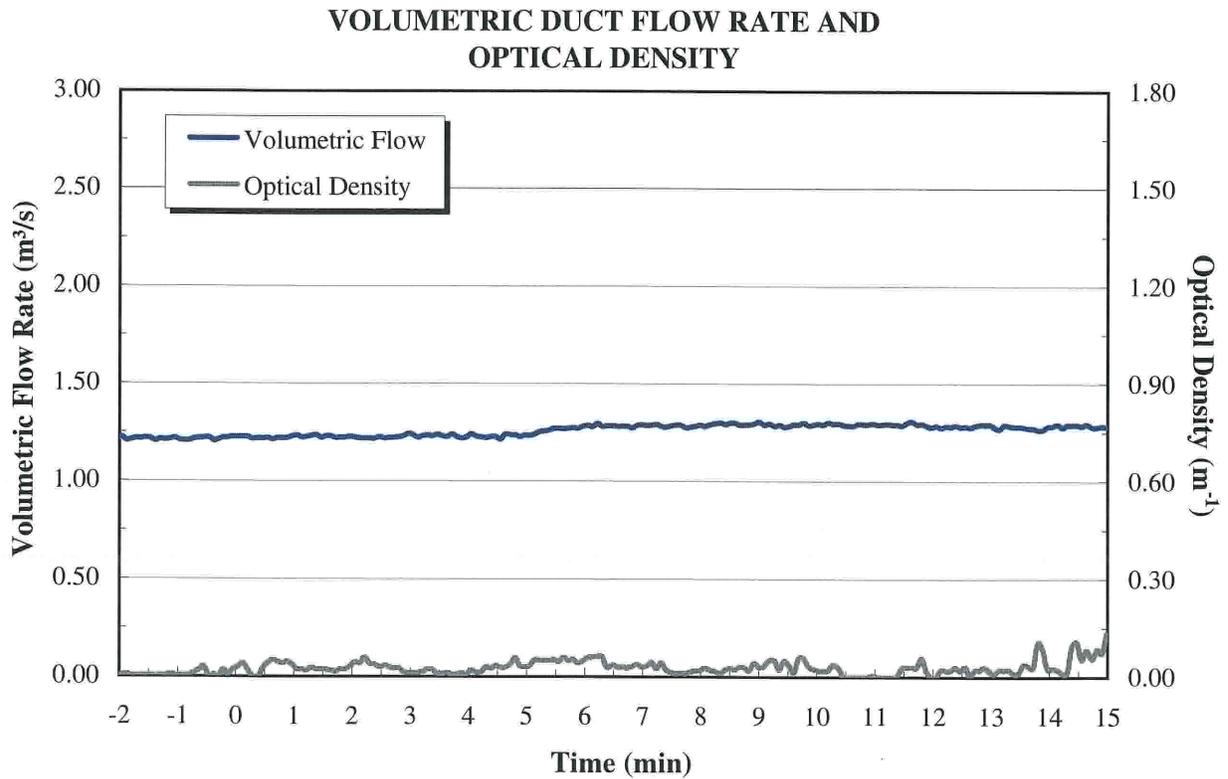
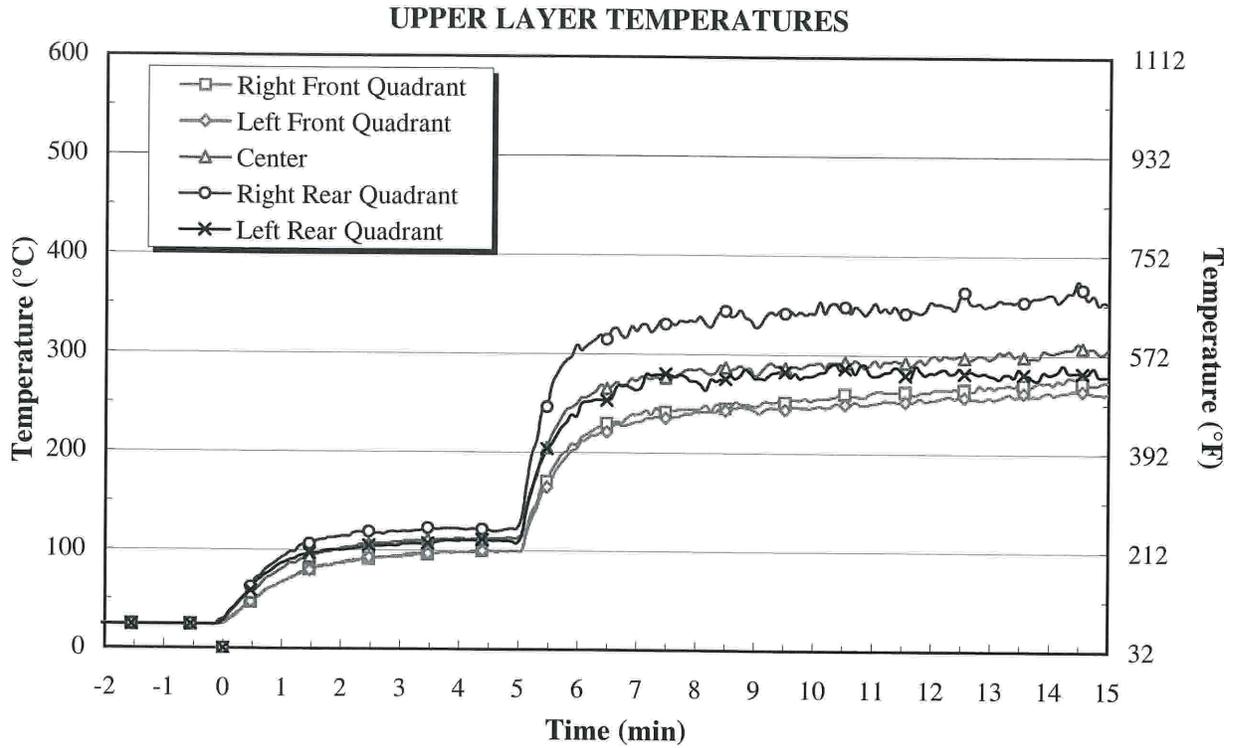
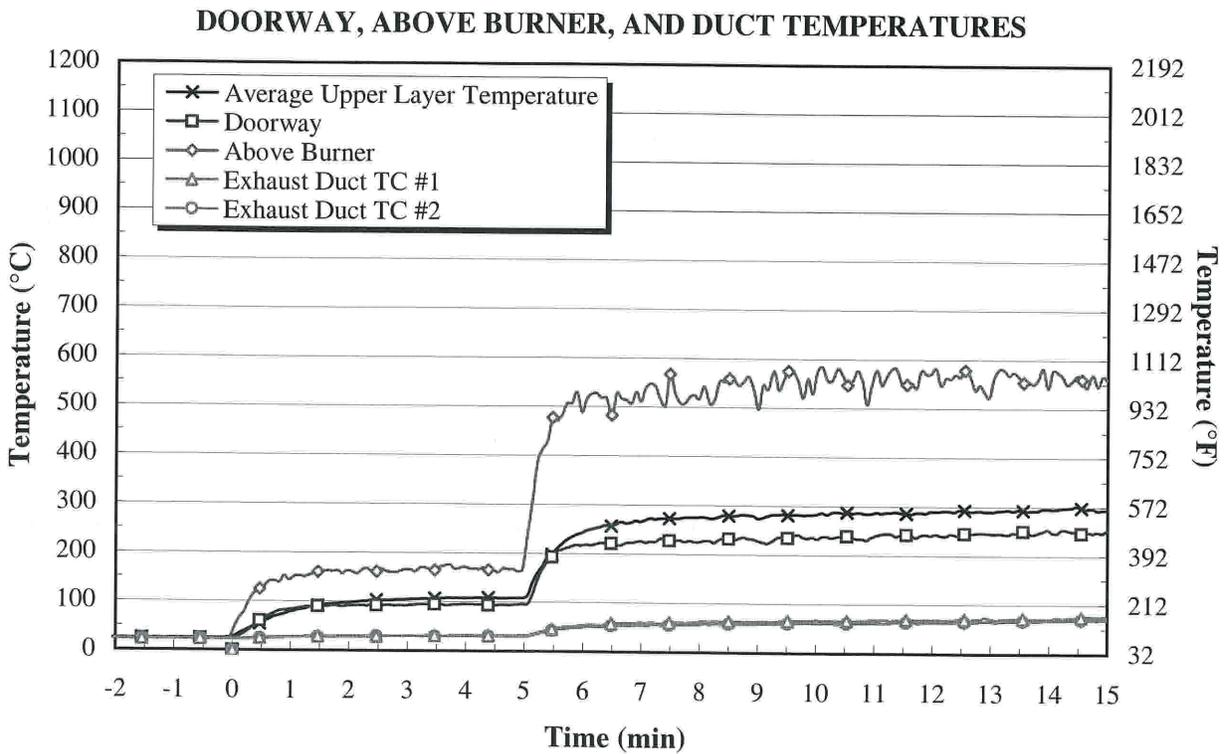
Maximum HRR_{total}	177 kW	at 10 min 11 s
Average HRR_{total}	121 kW	
Total Heat Released	109 MJ	
Maximum $HRR_{excl. burner}$	17 kW	at 10 min 11 s
Average $HRR_{excl. burner}$	4 kW	
Total Heat Released (Excluding Burner)	4 MJ	
Maximum Smoke Release Rate	0.40 m ² /s	at 14 min 59 s
Average Smoke Release Rate	0.09 m ² /s	
Total Smoke Released	78 m ²	
Maximum Optical Density	0.13 1/m	at 14 min 59 s
Maximum Duct Flow Rate	1.28 m ³ /s	
Average Optical Density	0.030 1/m	
Average Volumetric Duct Flow Rate	1.26 m ³ /s	
Total Heat Flux to the Floor	1.8 kW/m ²	at 14 min 28 s
Max. Average Upper Layer Temperature	302 °C 575 °F	at 14 min 28 s
Maximum Doorway Temperature	254 °C 488 °F	at 13 min 58 s
